## TECHNICAL SERVICE BULLETIN

### 2.0L EcoBoost - Rattle Noise And Cracked Flexplate

**19-2236**  
06 August 2019

| <b>Ford</b><br>2015-2018 Edge |

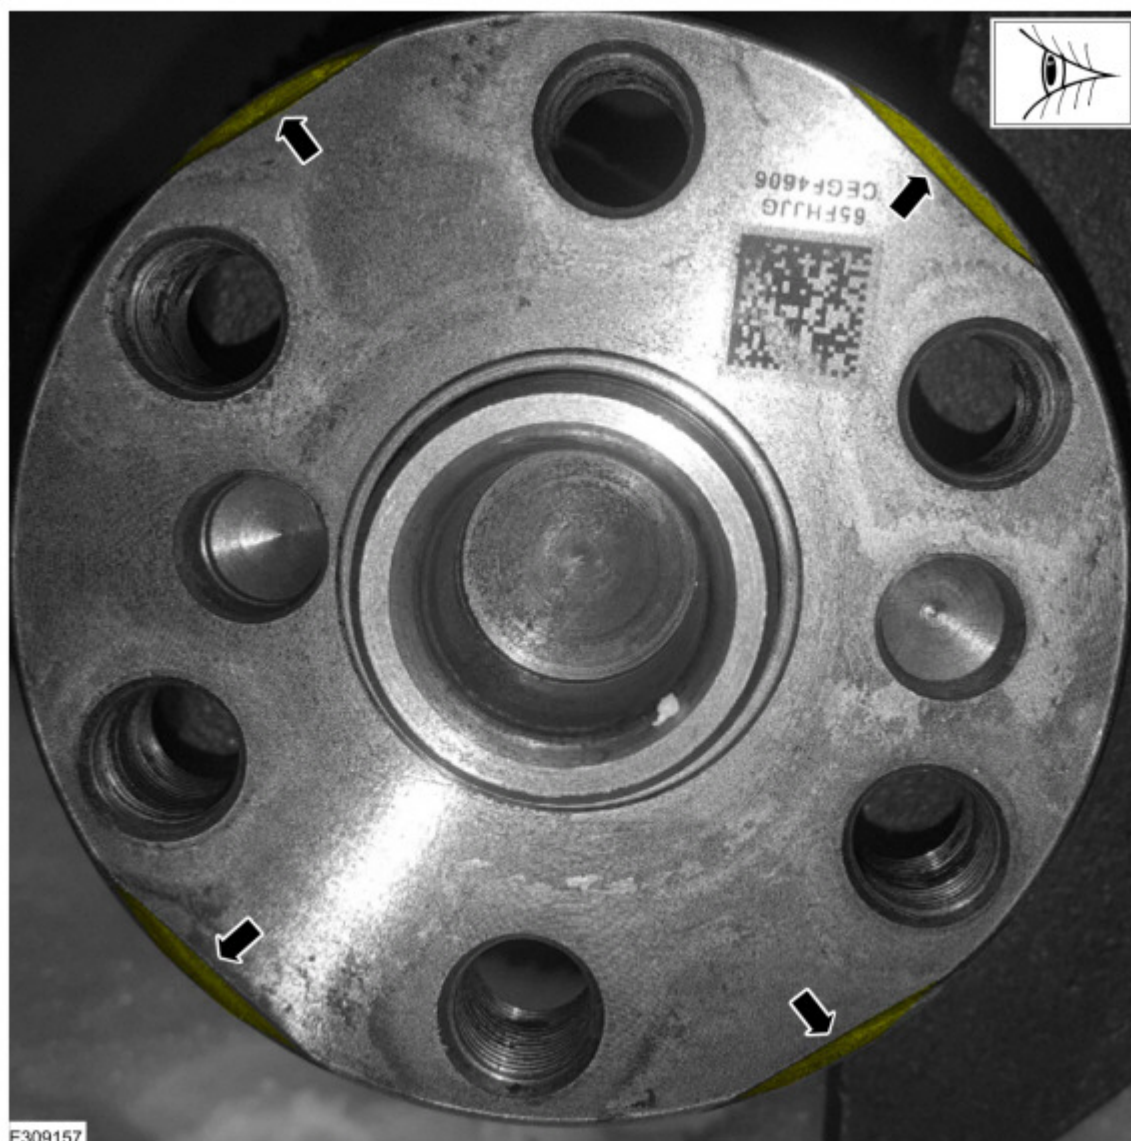
Figure 1

4. Remove the flexplate and inspect the crankshaft mounting face for damage. Are indentations present on the edges of the crankshaft? (Figure 1)
  - (1). Yes - replace the torque converter, flexplate, flexplate bolts, and transmission front pump. Refer to WSM, Section 307-01A. If dowel pins are damaged or missing, replace as needed. Proceed to Step 5.

- (2). No - replace the torque converter, flexplate, flexplate bolts, and transmission front pump. Refer to WSM, Section 307-01A. If dowel pins are damaged or missing, replace as needed. Proceed to Step 46.
