MODEL
2017MY
Sportage (QL)

NUMBER
207

TECHNICAL SERVICE BULLETIN

**SERVICE ACTION: WINDOW REGULATOR
DRUM GEAR REPLACEMENT (SA418)**

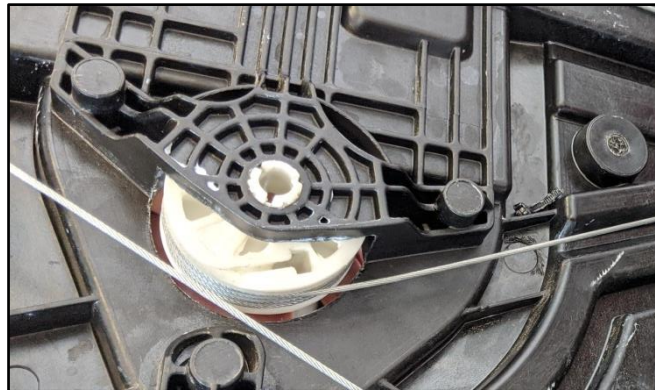
This bulletin provides the procedure to replace the window regulator drum/gear on some 2017MY Sportage (QL) vehicles, produced from December 15, 2015 through May 31, 2016, which may exhibit an inoperative front (left and/or right side) window regulator concern due to a drum gear separating and/or breaking. To prevent/correct this concern, install the improved drum gear to both front door window regulators. Before conducting the procedure, verify the vehicle is included in the list of affected VINs.
