Re: Petition for defect investigation of Hyundai/Kia oil drain pan assemblies

The H/K Oil Drain Pan Assembly Defects

EXAMPLES Factory Paint-Fused Oil Drain Plug and Gasket

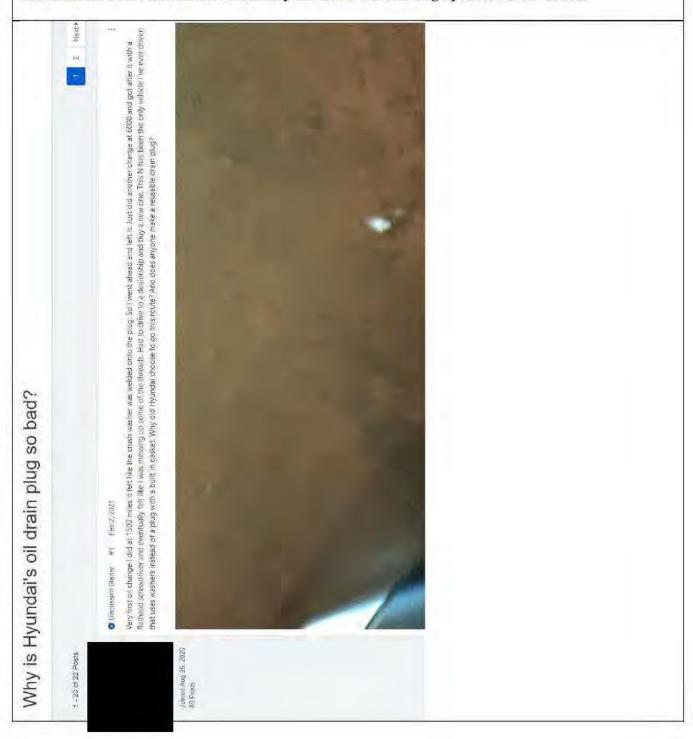
2019 Hyundai Veloster owner: "Very first oil change I did at 1500 miles it felt like the crush washer was welded onto the plug. So I went ahead and left it. Just did another change at 6000 and got after it with a flathead screwdriver and eventually felt like I was messing up some of the threads."
