Technical Bulletin

Model(s)	Year(s)	Eng. Code	Trans. Code	VIN Range From	VIN Range To
Golf Sportwagen, Golf Alltrack	2015-2018	All	All	AU_FM500001	AU_JM752863

60 17 04 September 6, 2017 2045816 Supersedes Technical Bulletin 60-16-09 (V601609) dated November 22, 2016 to include additional model and model year applicability.

Water Leak from Panoramic Sunroof (U.S. Only)

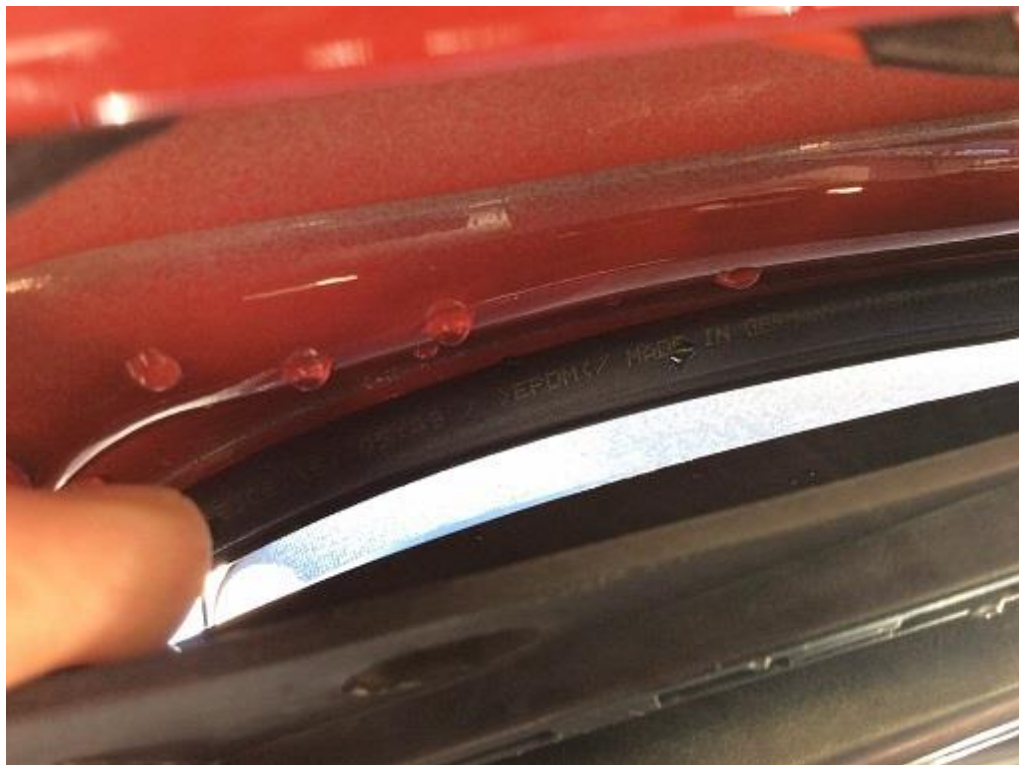
Verify the customer complaint. Water leaks may occur around the perimeter of the sunroof frame, between the frame and body of vehicle (See Figure 1). Water may also be found leaking through the sunroof cable guides in the sunroof frame (See Figure 2).

Figure 1: water leaking between sunroof frame and body

Incorrect rework in production of the welding points of the sunroof frame area. Spot welds around the perimeter of the sunroof opening may be too large. This prevents the outer sunroof seal from properly adhering to the body of the vehicle, allowing water to leak through the seal.

Insufficient cleaning process prior to applying outer sunroof seal. The sunroof frame opening may have been improperly cleaned prior to application of the acrylic tape on the outer sunroof seal. This prevents the outer sunroof seal from properly adhering to the body of the vehicle, allowing water to leak through the seal.

- Remove the sunroof frame. See repair manual group 60 in ELSA.
- Remove the outer sunroof seal and inspect the spot welds around the inside edge of the body flange.
- If large spot welds are found (See Figure 3), grind the weld(s) down smooth and repaint the area(s).

- Thoroughly clean the body flange using cleaning solution D 00940104 and a microfiber cloth.
- Install a new outer sunroof seal according to the repair instructions in ELSA. See repair manual group 60 in ELSA.
- Reinstall the sunroof frame. See repair manual group 60 in ELSA.
- Water test the vehicle to verify there are no further water leaks.
- Reinstall the headliner. See repair manual group 70 in ELSA.

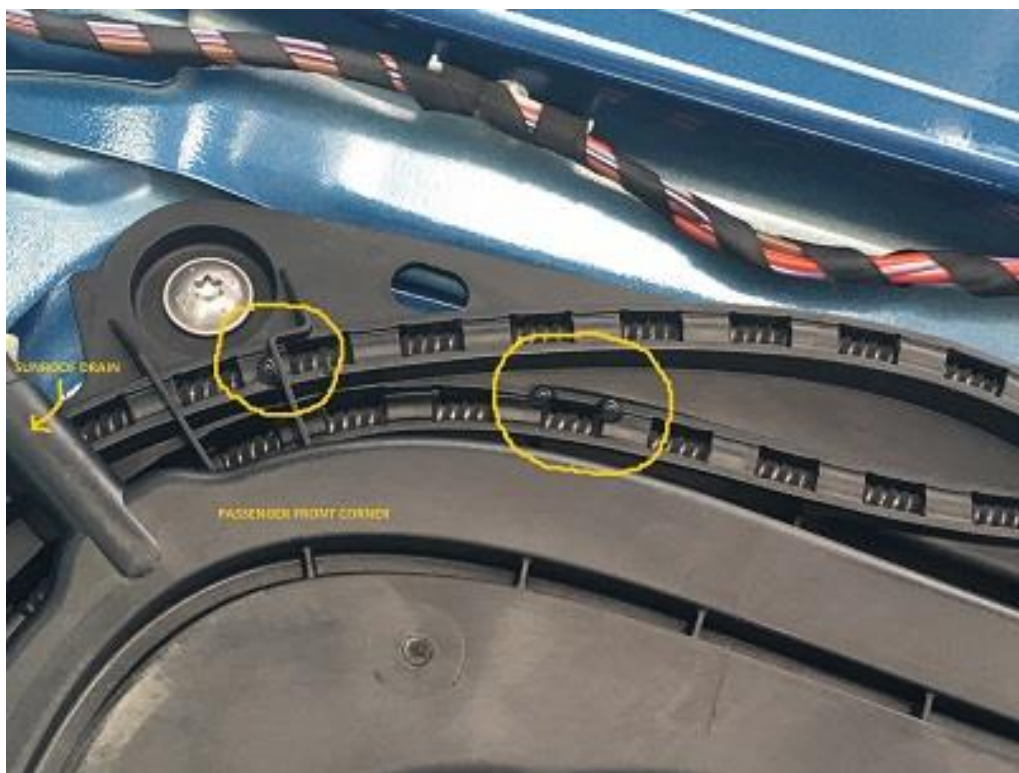
Figure 2: water leaking through sunroof cable guides

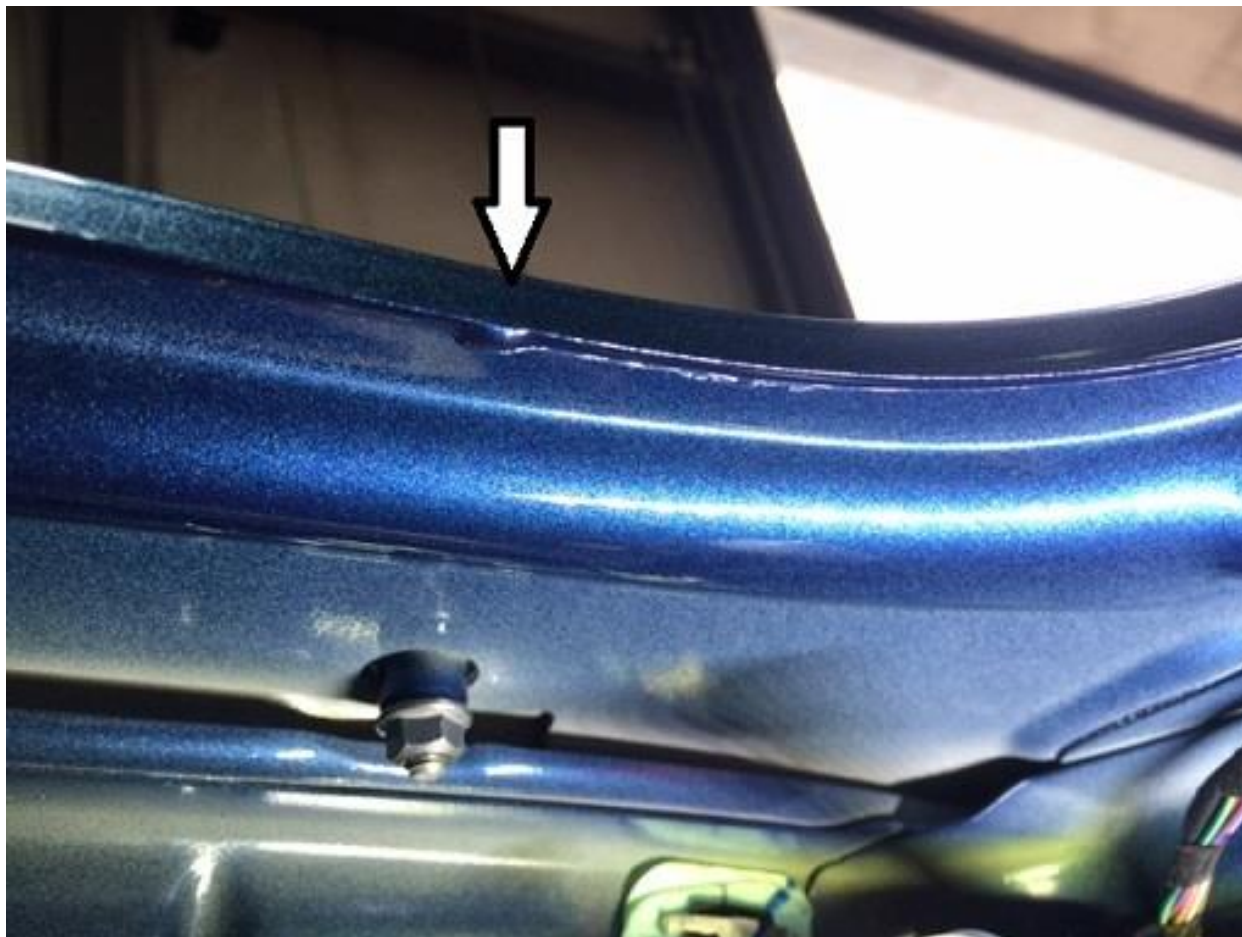
Figure 3, large spot weld
