**UNITED STATES DISTRICT COURT
SOUTHERN DISTRICT OF FLORIDA**

CLASS ACTION COMPLAINT

1. GM designed, manufactured, distributed, marketed, sold, and leased Model Year 2010-2017 Chevrolet Equinox vehicles with 2.4-liter engines (“Class Vehicles” or “Vehicles”) to Plaintiffs and Class Members. These engines were denominated within GM as the “LAF” and “LEA” engines (also referred to herein as the “EcoTech 2.4L” engine).

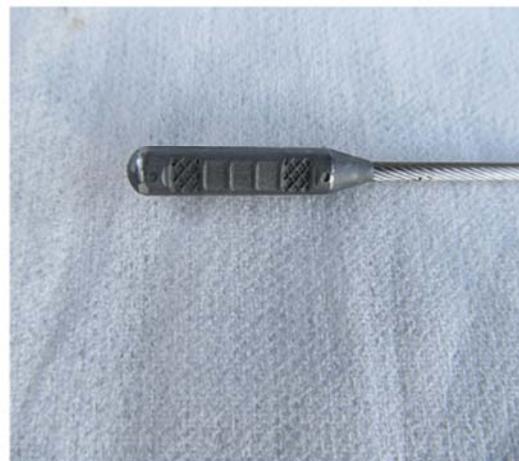
3339530

Important: When checking the oil level with the oil dipstick design shown below, please note that the oil volume per notch is not linear due to the shape of the block. The upper notches (relative to the top of the handle) equal 0.24 quart (0.227 L) between each notch while the lower notches only equal 0.14 quart (0.132 L) between each notch. As a result, no oil will appear on the dipstick if it is low on oil by approximately 1.25 quarts (1.18 L) or more. When determining the oil consumption rate, the oil volume added to return it to the starting location is the total amount of oil consumed. The consumption rate must be documented on a repair order.

Notice: Do not add too much oil. An overfill can lead to burn off of the excess oil. Advise the customer to wait until the oil is below the cross-hatched area at the tip of the dipstick before adding oil.

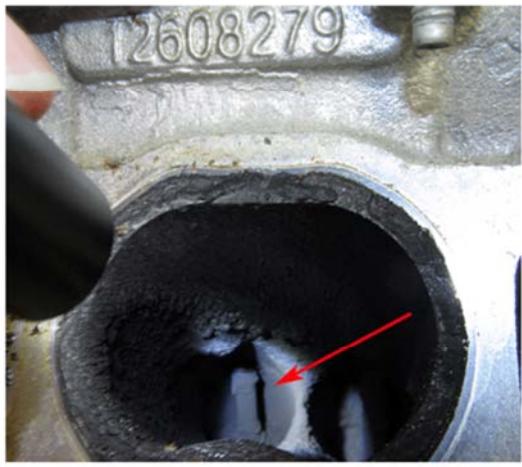
3409680

- Valves stems may have deposits build up on them. These deposits are characteristic of a direct inject engine. The valves stems do not need to be cleaned as they are not affecting engine performance (Refer to picture above).

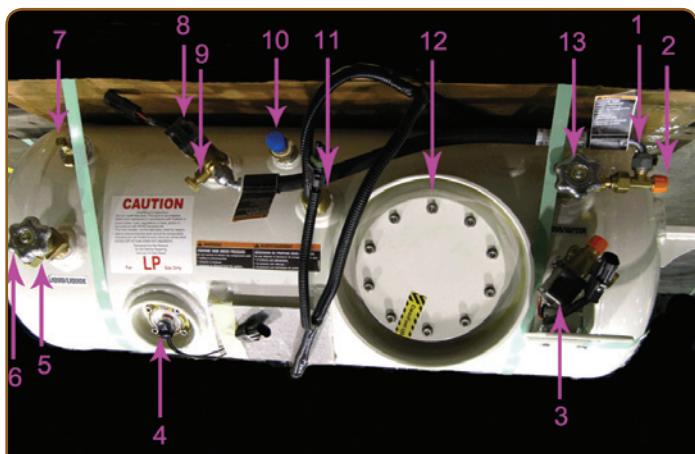
LPG Tank Components (front tank of 3-tank system shown)

The LPG system, including the tanks and tubing, has been designed to hold gas at a working pressure of 312.5 psi (2,154.6 kPa) and a burst pressure of 1,250 psi (8,618 kPa). It has also been tested for safety. Baffles are built into the tanks to keep the fuel pump submerged in liquid propane at all times.

1. LPG fuel bypass loop, mounted to a T-fitting on the return port of the fuel tank
2. Connection for the fuel return line from the distribution block
3. LPG cut-off solenoid, mounted to the outlet port of the fuel tank
4. Fuel level sensor
5. Liquid propane service valve and port
6. Manual shut-off for the liquid propane service valve (handle not included)
7. Spitter valve. Used for visual verification of 80% fill
8. LPG bypass loop solenoid and valve
9. Manual shut-off valve for LPG bypass loop
10. Fuel tank fill port and behind it, inside the tank is the 80% stop fill valve
11. Fuel tank electrical wiring harness pass-through for the internal fuel pump
12. Fuel tank access cover plate, for the internal components
13. Manual shut-off valve for the fuel return line

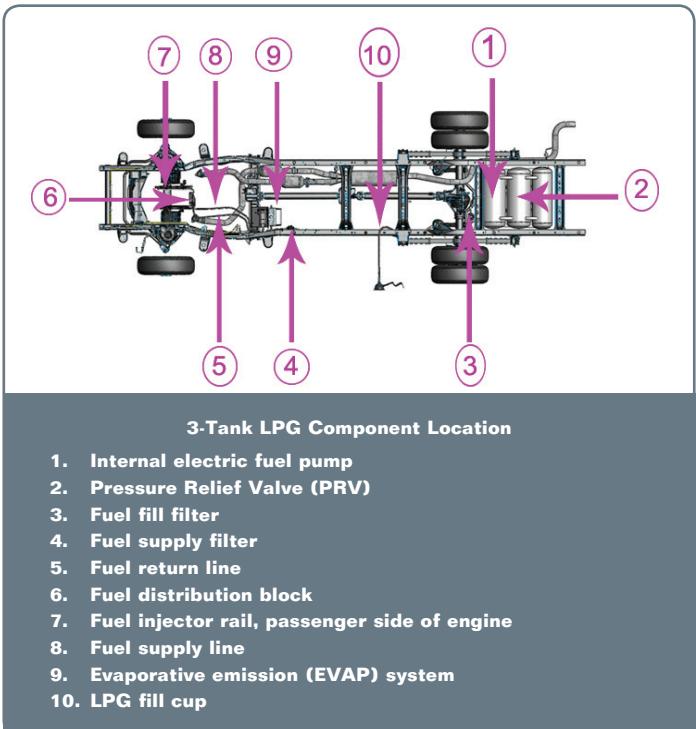
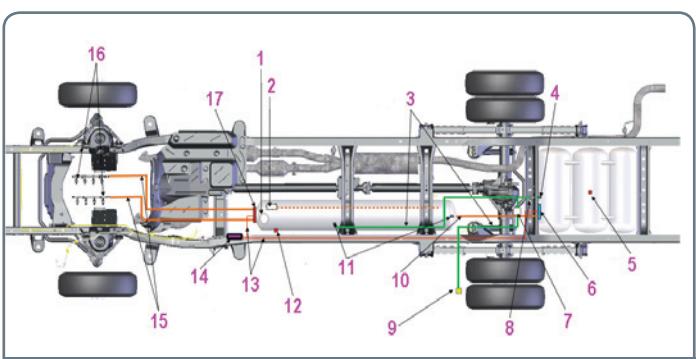
4-Tank LPG Component Location

1. Primary fuel pump (internal)
2. Scavenge fuel pump (internal)
3. Fuel fill lines
4. Rear fuel tank fill port and 80% stop fill valve
5. Pressure Relief Valve (PRV)
6. Fuel transfer pump or secondary transfer Liquid Propane Delivery Module (LPDM)
7. Fuel fill filter
8. Fuel fill line T-fitting
9. LPG fill cup, Sherwood Double Back Check Fill Valve, and fuel fill line
10. Transfer fuel line and port
11. Main fuel tank (mid-ship tank) fill port and transfer fuel line fill port
12. Pressure Relief Valve (PRV)
13. Electrical wiring harness
14. Liquid Propane Control Module (LPCM)
15. Fuel lines (concentric design)
16. Fuel rails and injectors
17. Liquid Propane Delivery Module (LPDM)

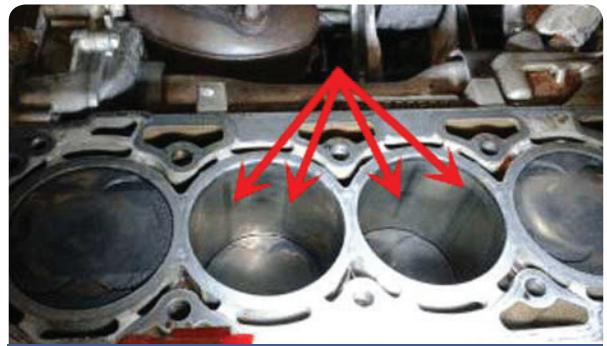
If the Service Information diagnostics does not isolate the cause of the condition and no obvious valve seal conditions are found, inspect the cylinder walls for obvious vertical "zebra stripes" as shown in the photo. In most cases, the cylinder head will have to be removed for inspection because these stripes may be hard to see with a bore scope. They also may not be apparent until the cylinder walls are cleaned with contact cleaner.

Vertical "zebra stripes" on the cylinder walls

If these stripes are NOT present, continue to follow the Service Information procedures and diagnosis to determine if there is another cause for the oil consumption, such as stuck rings, damaged rings, etc.

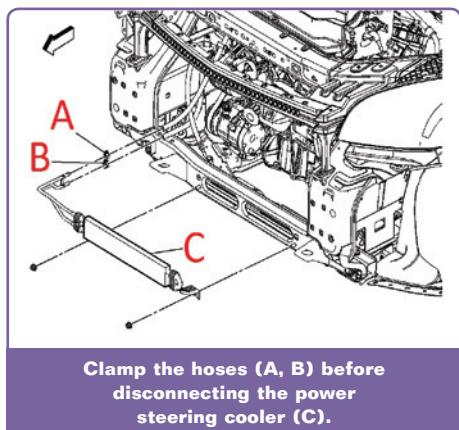
When replacing a power steering cooler, first block off the hoses near the cooler connection with the appropriate clamps. Next, disconnect the cooler from the lines and remove the cooler.

Pre-fill the new cooler on the bench and cap off the pre-filled cooler ends for installation.

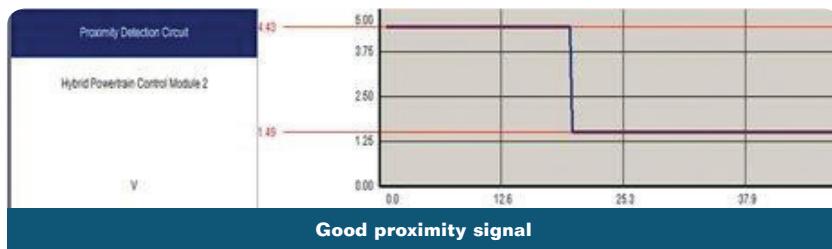
Good proximity signal

4. Review the snapshot and monitor the proximity detection signal for erratic operation during charging. Also manipulate the charge cord coupler (handle) in different directions and monitor for proximity voltage changes.

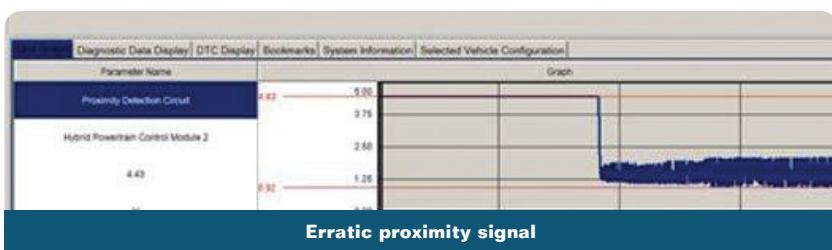
Erratic proximity signal

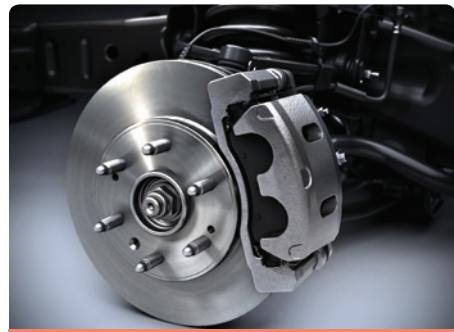
The Duralife brake rotors — a GM-exclusive technology — feature a hardened and strengthened surface to reduce corrosion. Duralife brake rotors are expected to last twice as long as conventional rotors and provide quieter braking with less vibration.

Duralife brake rotors

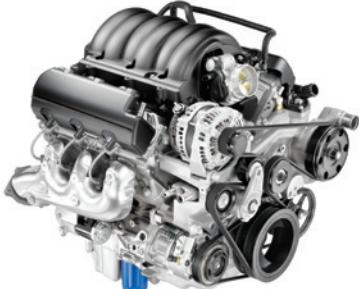
EcoTec3 4.3L V6

EcoTec3 engines feature three state-of-the-art technologies — direct injection, V4 Active Fuel Management (cylinder deactivation) and continuously variable valve timing — to make the most of power, torque and efficiency across a broad range of operating conditions.

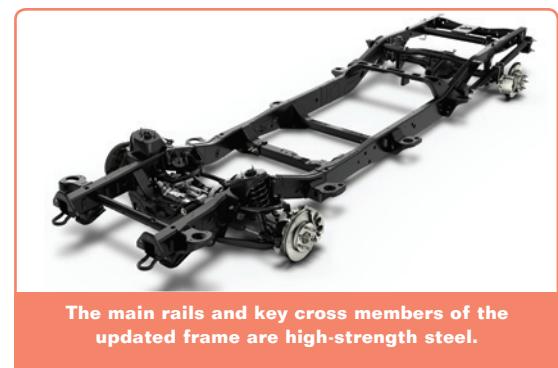
In addition, new shear-style body mounts tune out both up-and-down and side-to-side movement for a quieter, more comfortable ride. Double cab and crew cab models have a set of hydraulic rear body mounts to further isolate the cabs.

The main rails and key cross members of the updated frame are high-strength steel.

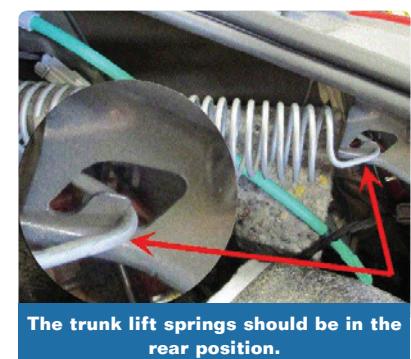
The trunk lift springs should be in the rear position.

Check for the proper position of both trunk hinge springs. There are two possible tension settings for the springs that will affect the speed the trunk lid will open.

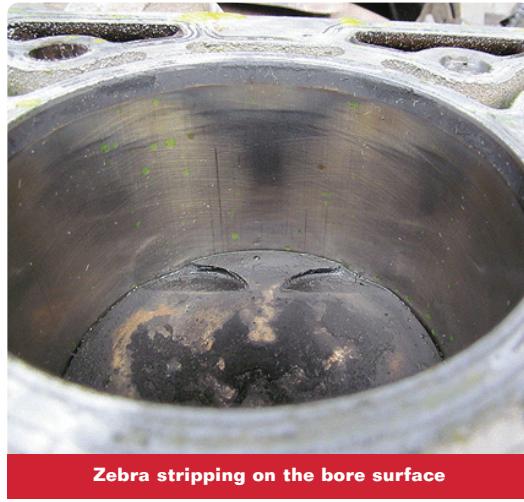
On 2010-2011 vehicles built before March 2011, there is a strong correlation between leaking high pressure fuel pumps diluting the oil and causing the ring wear. Due to this, check the fuel pump, balance chain, balance chain tensioner and timing chain for the proper part numbers. The updated fuel pump has an enhanced seal.

Zebra stripping on the bore surface

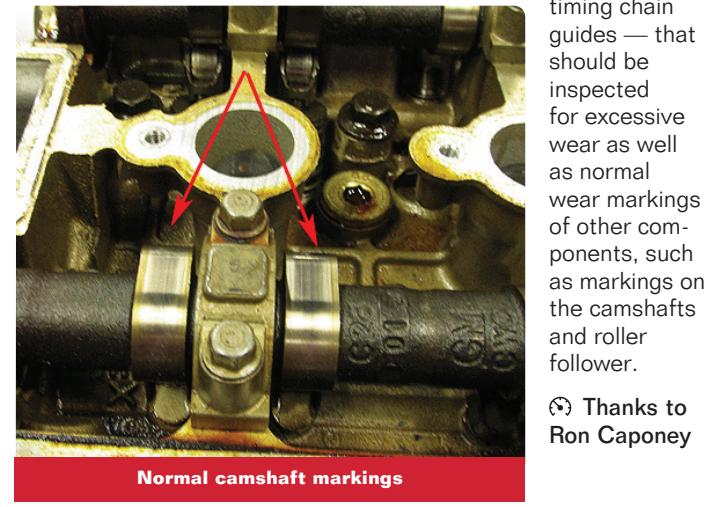
Normal camshaft markings

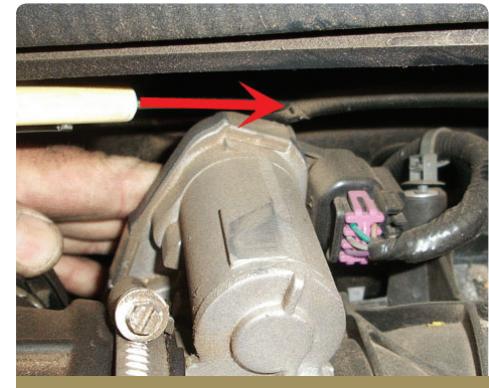
Inspect the evaporative emission canister purge pipe for contact with the throttle body. If contact is present, replace the purge pipe and secure it to eliminate future contact. Clear any set DTCs.

Inspect for purge pipe contact with the throttle body.

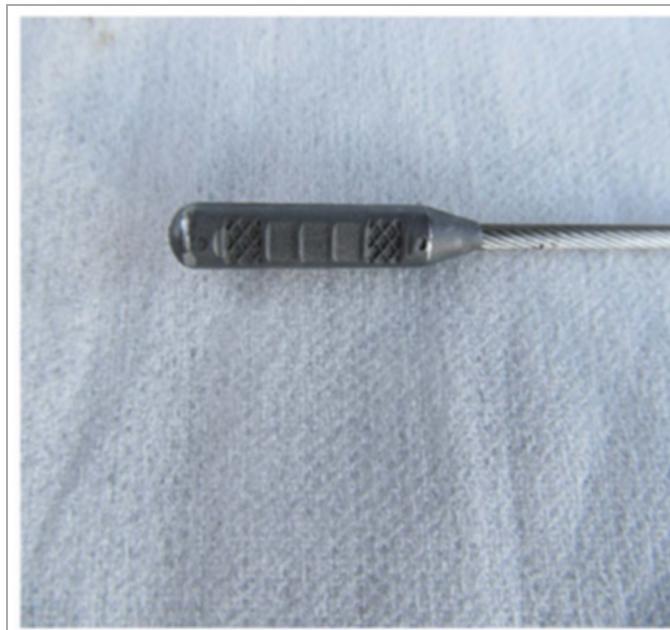
Do not add too much oil. An overfill can lead to burn off of the excess oil. Advise the customer to wait until the oil is below the cross-hatched area at the tip of the dipstick before adding oil.

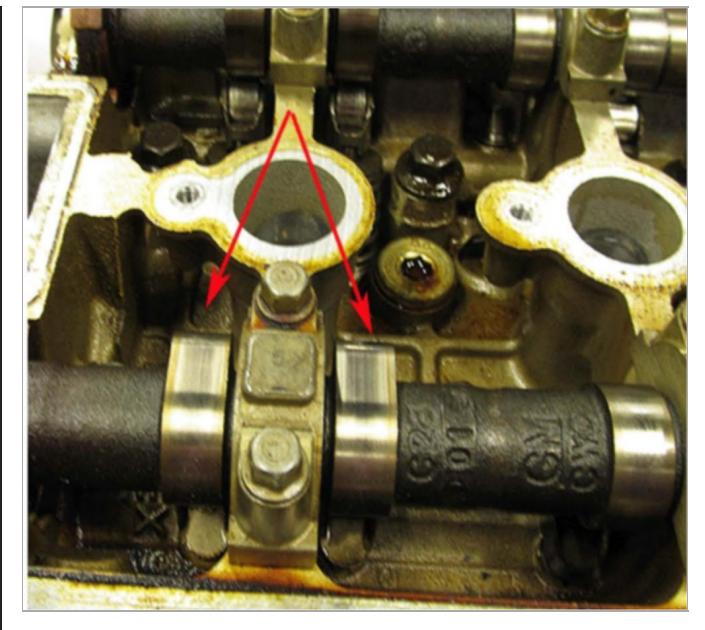
[^]Camshafts and roller follower will have wear markings. This is normal and do not need to be replaced (refer to picture above).

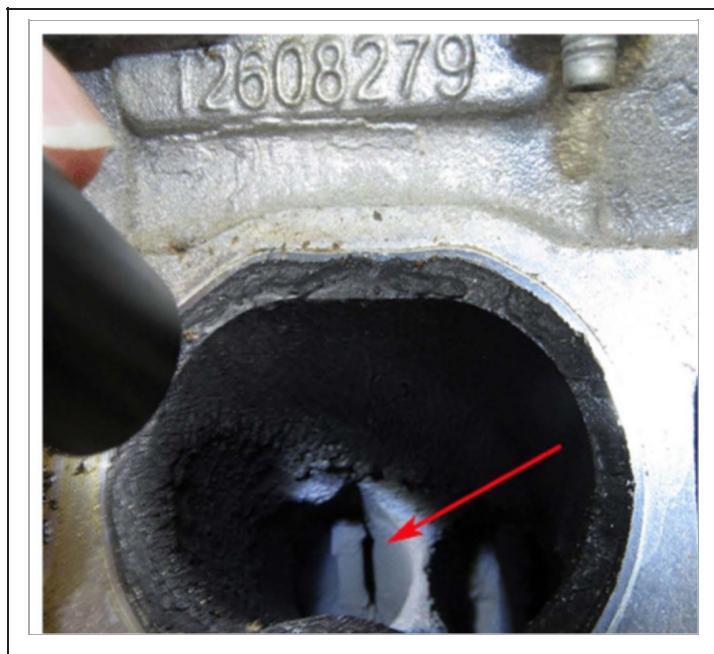
[^]Valves stems may have deposits build up on them. These deposits are characteristic of a direct inject engine. The valves stems do not need to be cleaned as they are not affecting engine performance (Refer to picture above).

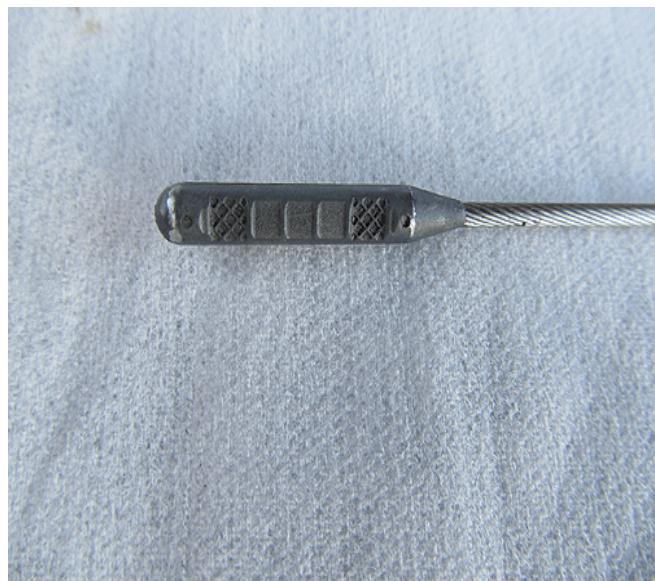
3339530

Important: When checking the oil level with the oil dipstick design shown below, please note that the oil volume per notch is not linear due to the shape of the block. The upper notches (relative to the top of the handle) equal 0.24 quart (0.227 L) between each notch while the lower notches only equal 0.14 quart (0.132 L) between each notch. As a result, no oil will appear on the dipstick if it is low on oil by approximately 1.25 quarts (1.18 L) or more. When determining the oil consumption rate, the oil volume added to return it to the starting location is the total amount of oil consumed. The consumption rate must be documented on a repair order.

Notice: Do not add too much oil. An overfill can lead to burn off of the excess oil. Advise the customer to wait until the oil is below the cross-hatched area at the tip of the dipstick before adding oil.

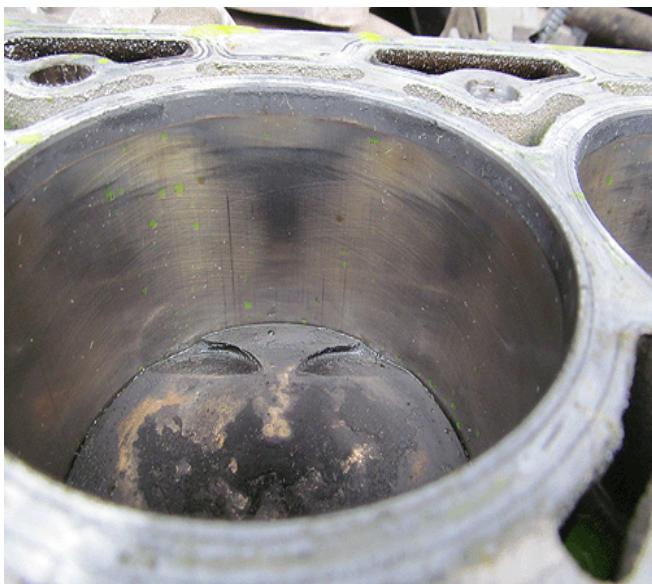
3339531

The repair is to replace the pistons and rings. In some cases the bore surface may not have a uniform look to the finish (zebra stripes) as shown below. As a result, some technicians may question whether the engine should be repaired or replaced. After careful evaluation, GM Powertrain has determined that the new pistons and rings will perform correctly in bores that have this appearance so engine replacement should not be necessary. The cylinder bores do not need any machine or honing work performed on them. Refer to the picture below for acceptable surface finishes.

Acceptable Cylinder that Does Not Appear Uniform (Zebra Stripes)

Note: The repair is to replace the pistons and rings. In some cases the bore surface may not have a uniform look to the finish (zebra stripes) as shown in Technical Service Bulletin 13-06-01-003F. As a result, some technicians may question whether the engine should be repaired or replaced. After careful evaluation, GM Powertrain has determined that the new pistons and rings will perform correctly in bores that have this appearance so engine replacement should not be necessary. The cylinder bores do not need any machine or honing work performed on them. Refer to Technical Service Bulletin 13-06-01-003F for more information.

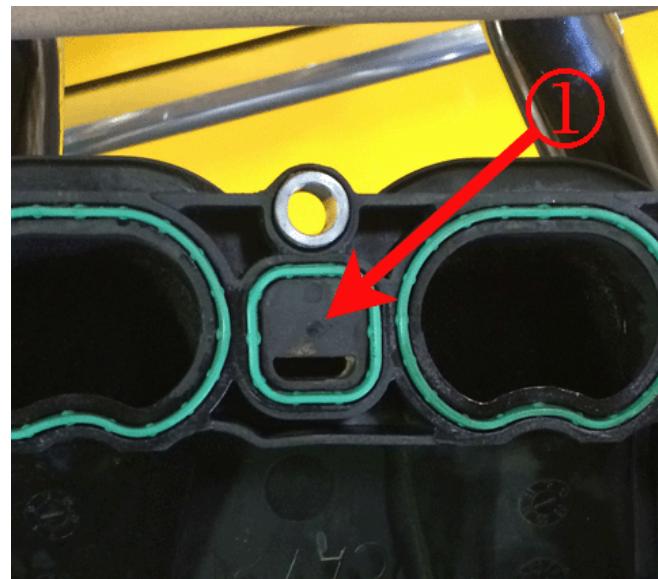
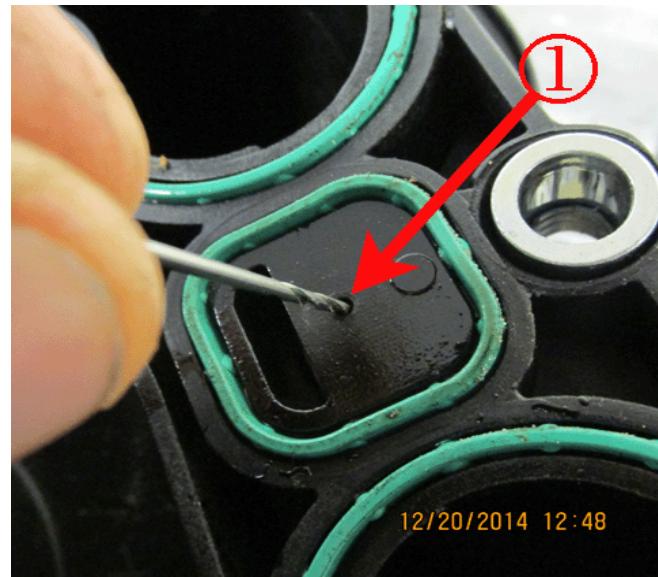
3704956

Clean any ice/sludge/water/carbon out of the PCV pipes/hoses, the PCV nipple on the cam cover, the PCV orifice between the #2 and #3 intake runners (use a 1/16 inch drill bit as illustrated below).

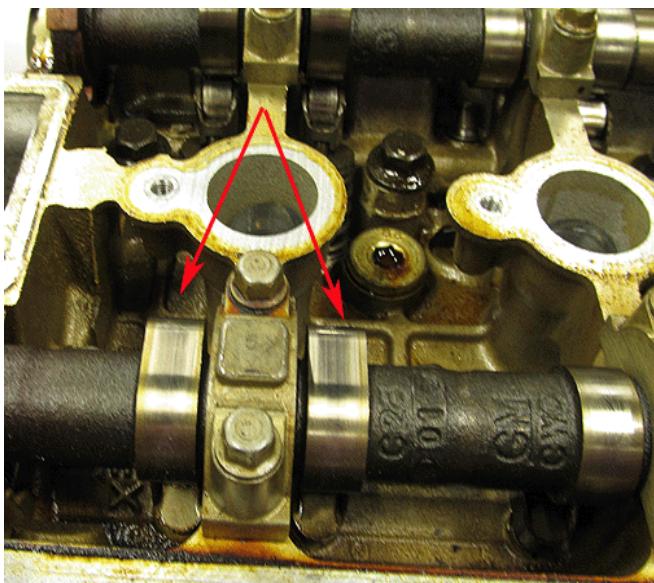
3409678

- Camshafts and roller follower will have wear markings. This is normal and do not need to be replaced (refer to picture above).

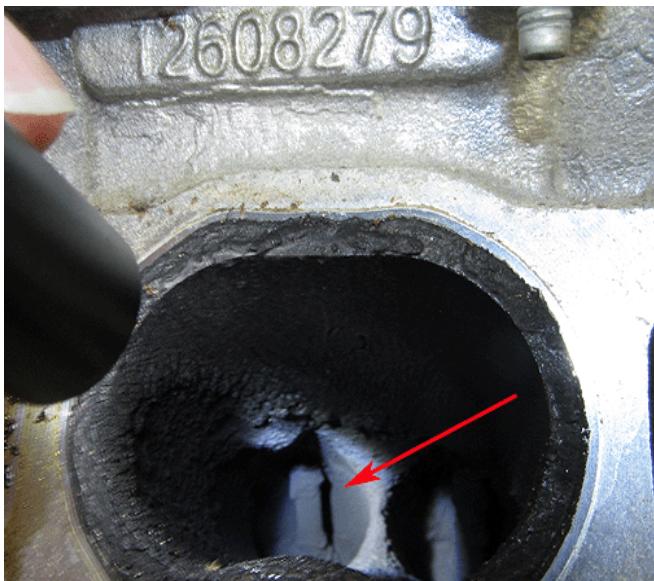
3409680

- Valves stems may have deposits build up on them. These deposits are characteristic of a direct inject engine. The valves stems do not need to be cleaned as they are not affecting engine performance (Refer to picture above).
