**IN THE UNITED STATES DISTRICT COURT  
FOR THE NORTHERN DISTRICT OF ILLINOIS**

**CLASS ACTION COMPLAINT AND  
COMPLAINT FOR DAMAGES**

1. GM designed, manufactured, distributed, marketed, sold, and leased Model Year 2010-2017 Chevrolet Equinox and GMC Terrain vehicles with 2.4-liter engines (“Class Vehicles” or “Vehicles”) to Plaintiffs and Class Members. These engines were denominated within GM as the “LAF” and “LEA” engines (also referred to herein as the “EcoTech 2.4L” engine).

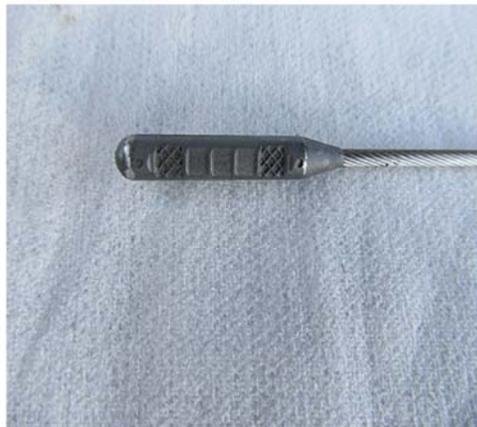
**Important:** When checking the oil level with the oil dipstick design shown below, please note that the oil volume per notch is not linear due to the shape of the block. The upper notches (relative to the top of the handle) equal 0.24 quart (0.227 L) between each notch while the lower notches only equal 0.14 quart (0.132 L) between each notch. As a result, no oil will appear on the dipstick if it is low on oil by approximately 1.25 quarts (1.18 L) or more. When determining the oil consumption rate, the oil volume added to return it to the starting location is the total amount of oil consumed. The consumption rate must be documented on a repair order.

**Notice:** Do not add too much oil. An overfill can lead to burn off of the excess oil. Advise the customer to wait until the oil is below the cross-hatched area at the tip of the dipstick before adding oil.

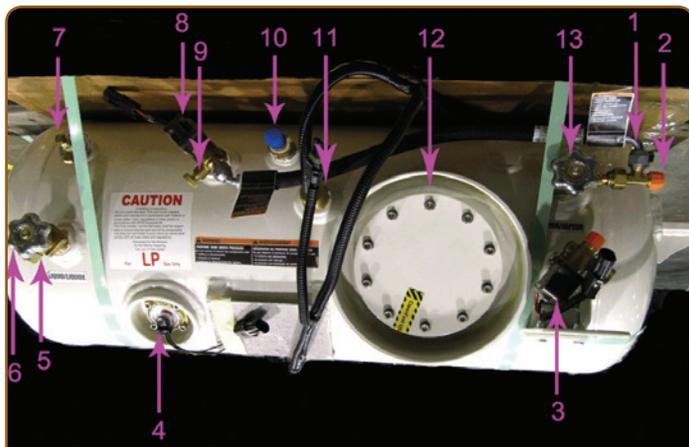
LPG Tank Components (front tank of 3-tank system shown)

1. LPG fuel bypass loop, mounted to a T-fitting on the return port of the fuel tank
2. Connection for the fuel return line from the distribution block
3. LPG cut-off solenoid, mounted to the outlet port of the fuel tank
4. Fuel level sensor
5. Liquid propane service valve and port
6. Manual shut-off for the liquid propane service valve (handle not included)
7. Spitter valve. Used for visual verification of 80% fill
8. LPG bypass loop solenoid and valve
9. Manual shut-off valve for LPG bypass loop
10. Fuel tank fill port and behind it, inside the tank is the 80% stop fill valve
11. Fuel tank electrical wiring harness pass-through for the internal fuel pump
12. Fuel tank access cover plate, for the internal components
13. Manual shut-off valve for the fuel return line

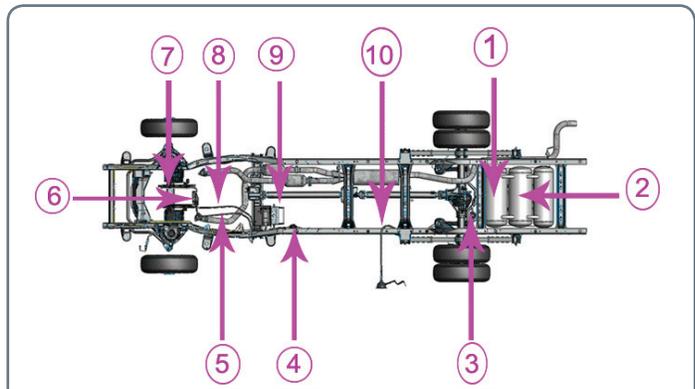
3-Tank LPG Component Location

1. Internal electric fuel pump
2. Pressure Relief Valve (PRV)
3. Fuel fill filter
4. Fuel supply filter
5. Fuel return line
6. Fuel distribution block
7. Fuel injector rail, passenger side of engine
8. Fuel supply line
9. Evaporative emission (EVAP) system
10. LPG fill cup

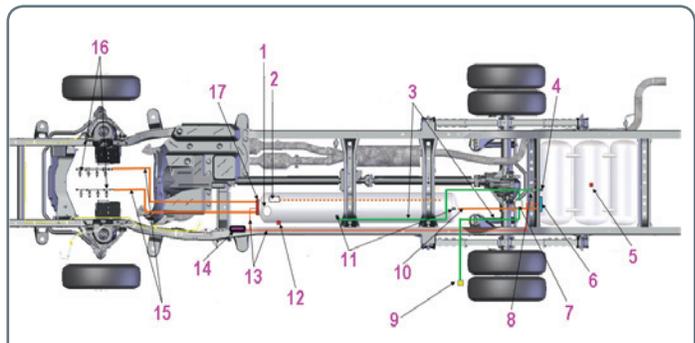
4-Tank LPG Component Location

1. Primary fuel pump (internal)
2. Scavenge fuel pump (internal)
3. Fuel fill lines
4. Rear fuel tank fill port and 80% stop fill valve
5. Pressure Relief Valve (PRV)
6. Fuel transfer pump or secondary transfer Liquid Propane Delivery Module (LPDM)
7. Fuel fill filter
8. Fuel fill line T-fitting
9. LPG fill cup, Sherwood Double Back Check Fill Valve, and fuel fill line
10. Transfer fuel line and port
11. Main fuel tank (mid-ship tank) fill port and transfer fuel line fill port
12. Pressure Relief Valve (PRV)
13. Electrical wiring harness
14. Liquid Propane Control Module (LPCM)
15. Fuel lines (concentric design)
16. Fuel rails and injectors
17. Liquid Propane Delivery Module (LPDM)

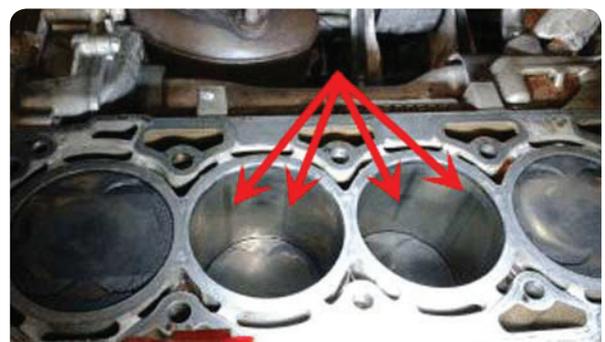
If the Service Information diagnostics does not isolate the cause of the condition and no obvious valve seal conditions are found, inspect the cylinder walls for obvious vertical "zebra stripes" as shown in the photo. In most cases, the cylinder head will have to be removed for inspection because these stripes may be hard to see with a bore scope. They also may not be apparent until the cylinder walls are cleaned with contact cleaner.

Vertical "zebra stripes" on the cylinder walls

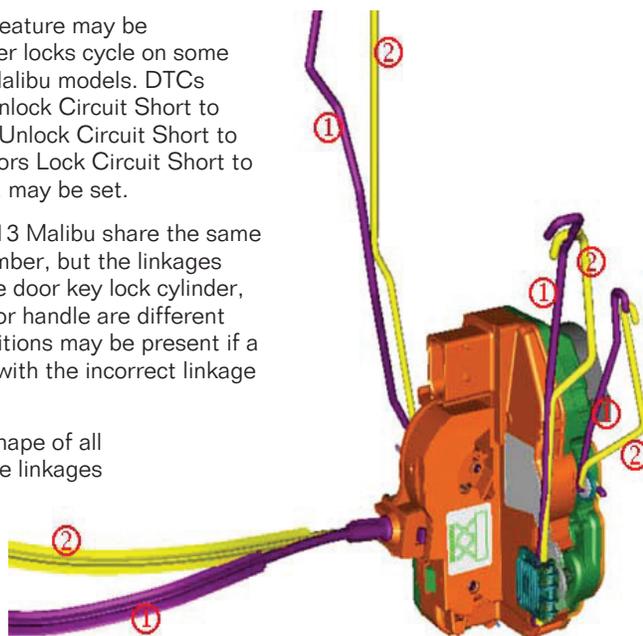
The illustration shows the shape of all linkages. Visually inspect the linkages and compare to the illustration to ensure the correct linkages are installed.

LaCrosse linkages are indicated in purple (1) and Malibu linkages are indicated in yellow (2).

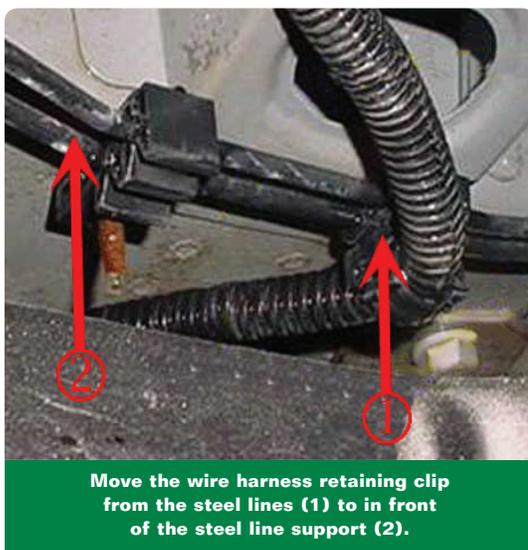
Move the wire harness retaining clip from the steel lines (1) to in front of the steel line support (2).

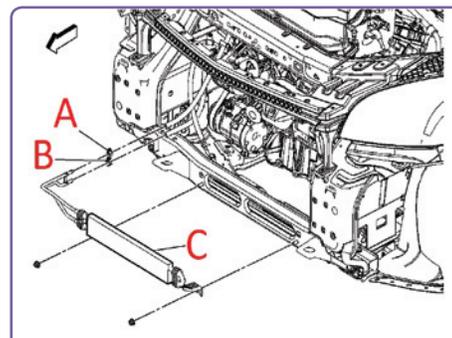
Clamp the hoses (A, B) before disconnecting the power steering cooler (C).

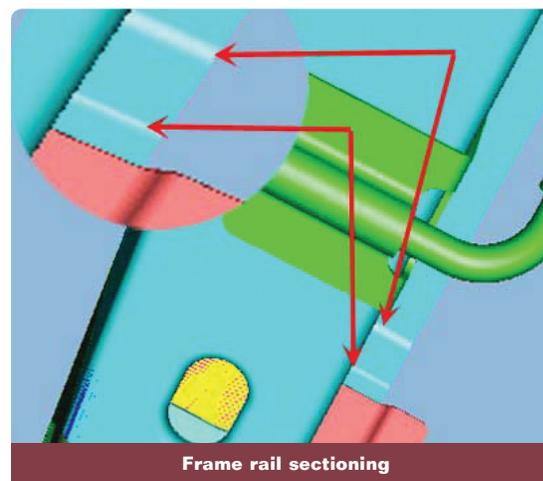
Frame rail sectioning

**TIP:** It is best to cut rearward of the bracket because of the flange change on the top of the rail.

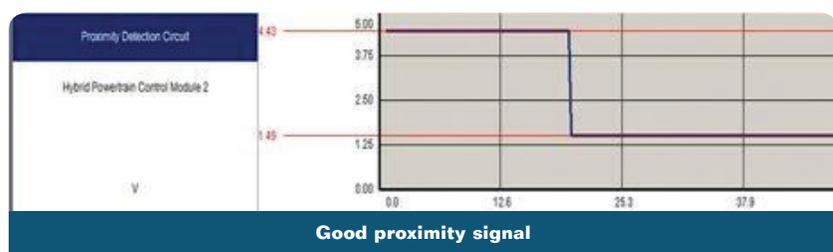
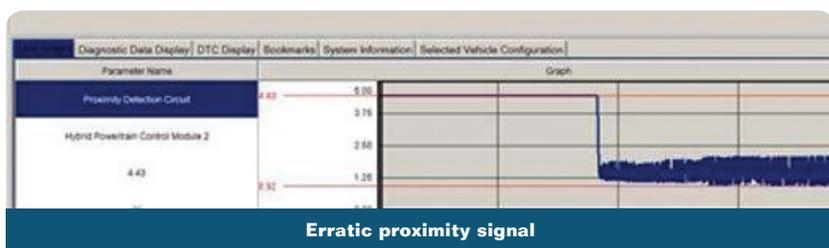
5. Refer to the following two photos that show a good proximity signal and a proximity signal that is erratic.
6. If the snapshot shows the erratic signal, and/or the condition changes when the charge cord coupler (handle) is manipulated, or the proximity signal does not drop to a steady 1.49 volts, inspect the charge port receptacle and wiring.

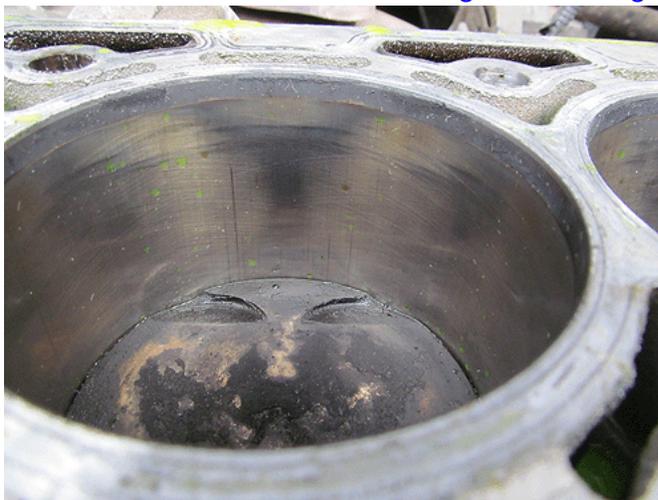
Fig 1

The "zebra" stripping on the bore surface (Fig. 1) is not an indication of a cylinder bore abnormality, but rather a transfer of material as it was worn down. The bores are still uniform and the new rings seal. The validation of the new ring pack was done on test blocks that had zebra striping. It's not necessary to do any surface treatment to the zebra striped bores when installing the new pistons and rings.

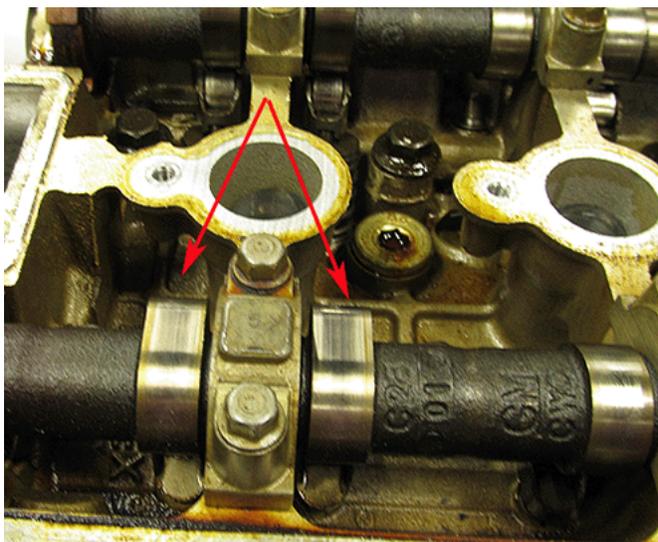
Fig 2

Refer to Bulletin #13-06-01-003B for additional information, including several other parts — such as balance chain guides and chain guides — that should be inspected for excessive wear as well as normal wear markings of other components, such as the camshafts (Fig. 2) and roller follower.

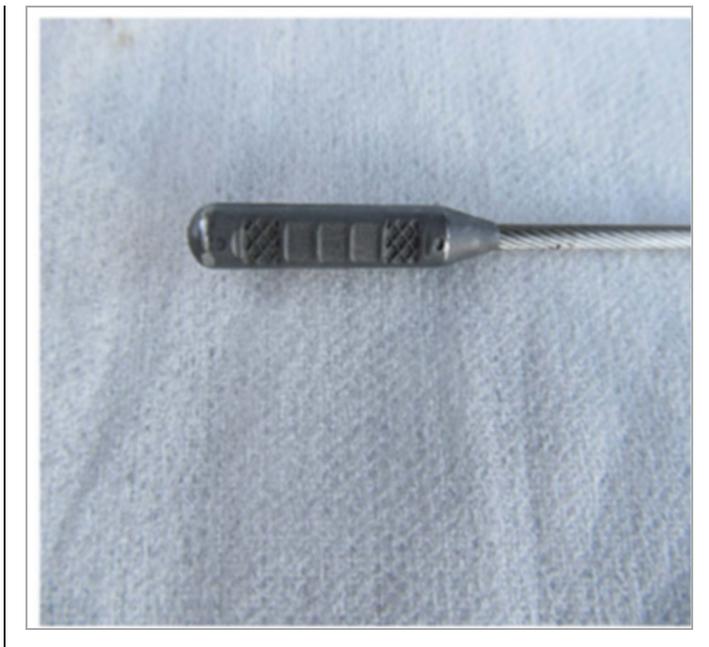
Do not add too much oil. An overfill can lead to burn off of the excess oil. Advise the customer to wait until the oil is below the cross-hatched area at the tip of the dipstick before adding oil.

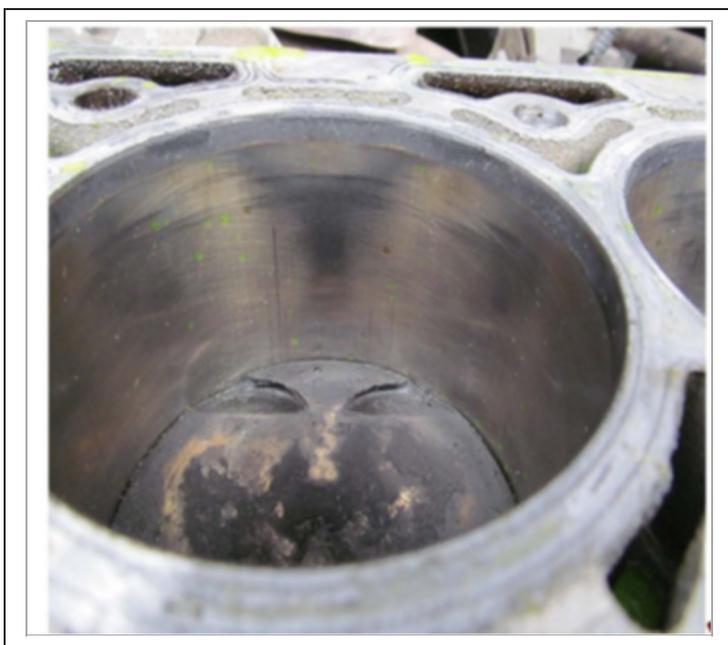
**Acceptable Cylinder that Does Not Appear Uniform (Zebra Stripes)**

The repair is to replace the pistons and rings. In some cases the bore surface may not have a uniform look to the finish (zebra stripes) as shown below. As a result, some technicians may question whether the engine should be repaired or replaced. After careful evaluation, GM Powertrain has determined that the new pistons and rings will perform correctly in bores that have this appearance so engine replacement should not be necessary. The cylinder bores do not need any machine or honing work performed on them. Refer to the picture below for acceptable surface finishes.

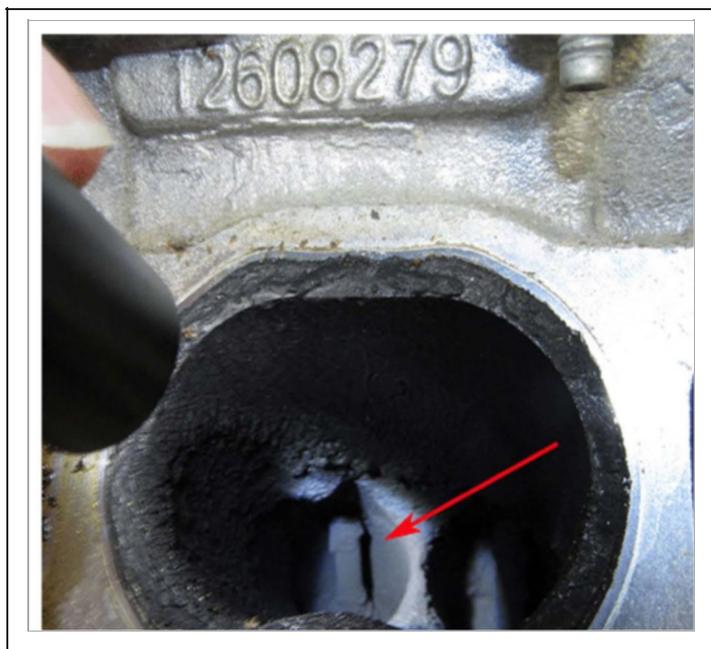
^Valves stems may have deposits build up on them. These deposits are characteristic of a direct inject engine. The valves stems do not need to be cleaned as they are not affecting engine performance (Refer to picture above).

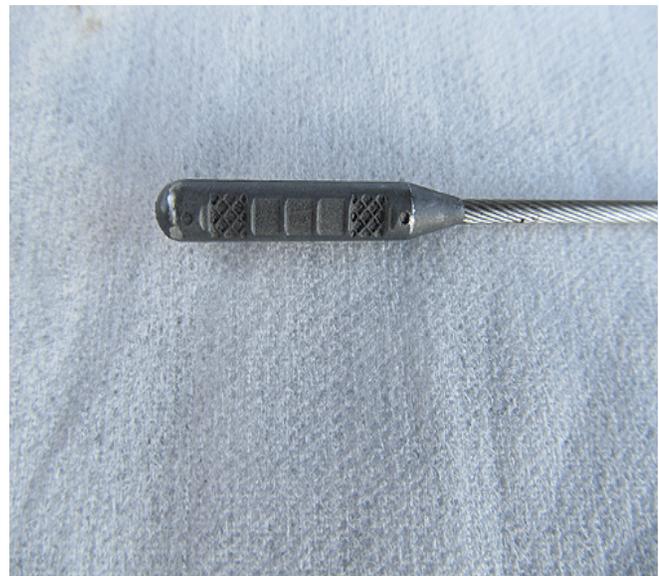
3339530

**Important:** When checking the oil level with the oil dipstick design shown below, please note that the oil volume per notch is not linear due to the shape of the block. The upper notches (relative to the top of the handle) equal 0.24 quart (0.227 L) between each notch while the lower notches only equal 0.14 quart (0.132 L) between each notch. As a result, no oil will appear on the dipstick if it is low on oil by approximately 1.25 quarts (1.18 L) or more. When determining the oil consumption rate, the oil volume added to return it to the starting location is the total amount of oil consumed. The consumption rate must be documented on a repair order.

**Notice:** Do not add too much oil. An overfill can lead to burn off of the excess oil. Advise the customer to wait until the oil is below the cross-hatched area at the tip of the dipstick before adding oil.

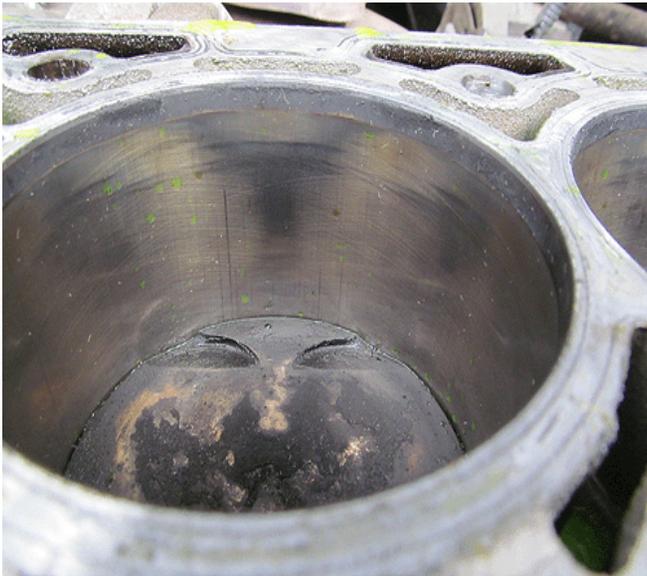
3339531

The repair is to replace the pistons and rings. In some cases the bore surface may not have a uniform look to the finish (zebra stripes) as shown below. As a result, some technicians may question whether the engine should be repaired or replaced. After careful evaluation, GM Powertrain has determined that the new pistons and rings will perform correctly in bores that have this appearance so engine replacement should not be necessary. The cylinder bores do not need any machine or honing work performed on them. Refer to the picture below for acceptable surface finishes.

### Acceptable Cylinder that Does Not Appear Uniform (Zebra Stripes)

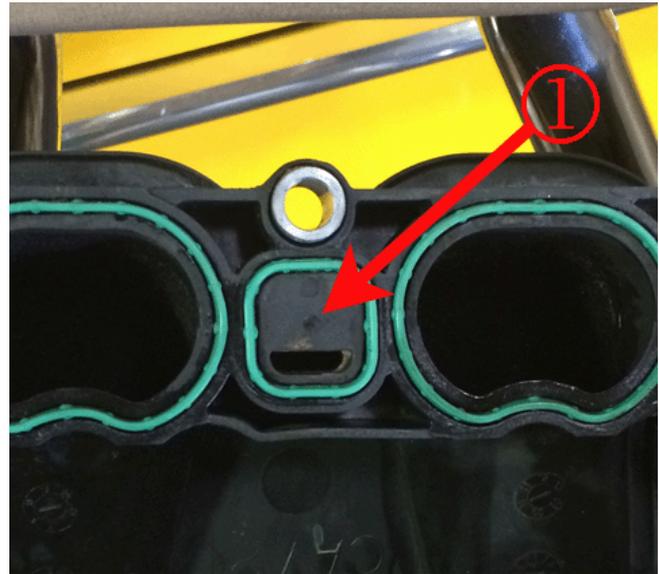
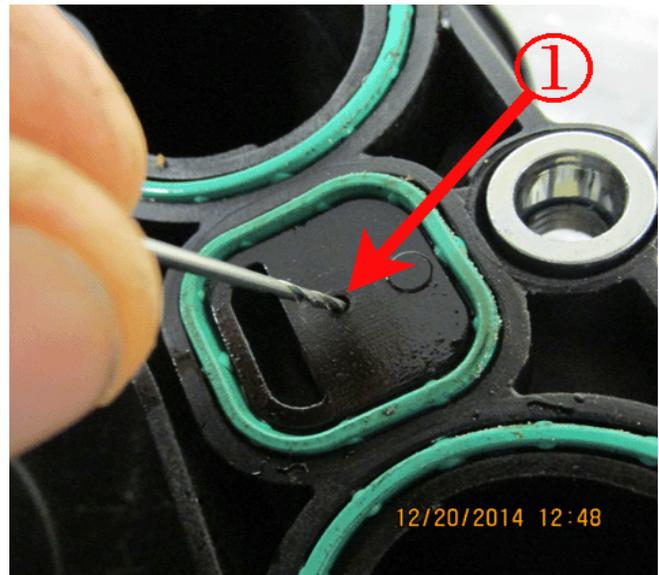
3704956

The oil consumption may have clogged/ reduced PCV flow. The PCV system should be serviced.

Clean any ice/sludge/water/carbon out of the PCV pipes/hoses, the PCV nipple on the cam cover, the PCV orifice between the #2 and #3 intake runners (use a 1/16 inch drill bit as illustrated below).

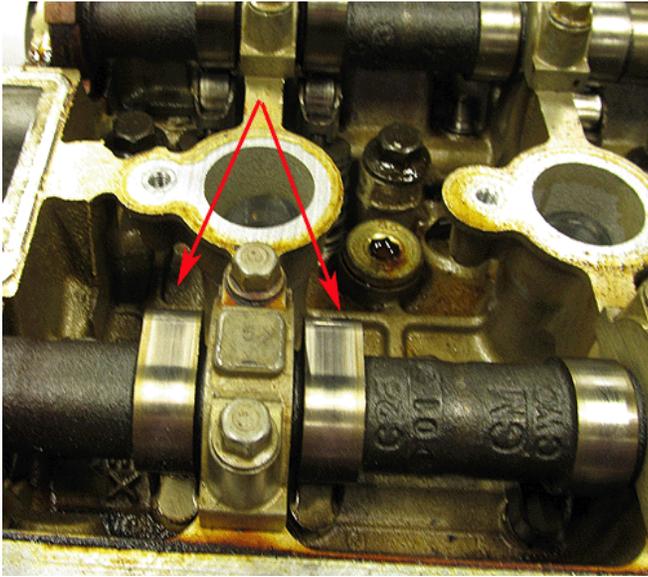
3409678

- Camshafts and roller follower will have wear markings. This is normal and do not need to be replaced (refer to picture above).

^Camshafts and roller follower will have wear markings. This is normal and do not need to be replaced (refer to picture above).

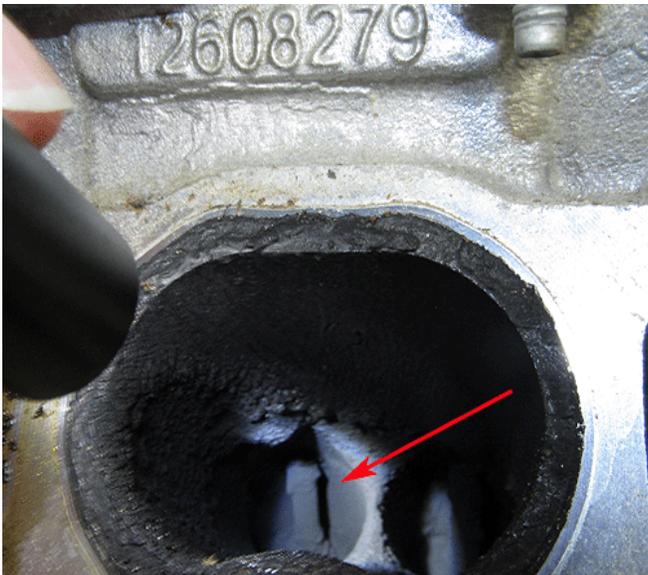
3409680

- Valves stems may have deposits build up on them. These deposits are characteristic of a direct inject engine. The valves stems do not need to be cleaned as they are not affecting engine performance (Refer to picture above).
