GROUP	MODEL
Safety Recall Campaign	2021-2022MY K5 (DL3a) and Sorento (MQ4a)
NUMBER	DATE
SC250 (Rev 2, 06/28/2023)	December 2022

SUBJECT: **8-SPEED DCT (DTC P1C2D03) INSPECTION /
REPLACEMENT / LOGIC IMPROVEMENT (SC250)**

This bulletin provides the procedure to inspect and, if necessary, replace the transmission on certain 2021-2022 Sorento (MQ4a) vehicles produced from October 26, 2020 through August 25, 2022 and certain K5 (DL3a) vehicles produced from November 16, 2020 through August 12, 2022, equipped with a 2.5L T-GDI / 8-speed dual clutch transmission (DCT). Also, this bulletin provides the procedure to improve the transmission control unit (TCU) logic with updated software on the subject vehicles. The electric oil pump within the 8-speed dual-clutch transmission (DCT) may experience an internal fault due to a quality deviation issue at the supplier. As a result, the subject vehicle may set a diagnostic trouble code (DTC) P1C2D03. This condition will cause the malfunction indicator lamp (MIL) to illuminate and a "stop safely immediately" message on the instrument cluster as well as audible chimes. If this condition occurs, the vehicle can be driven normally for 20-30 seconds

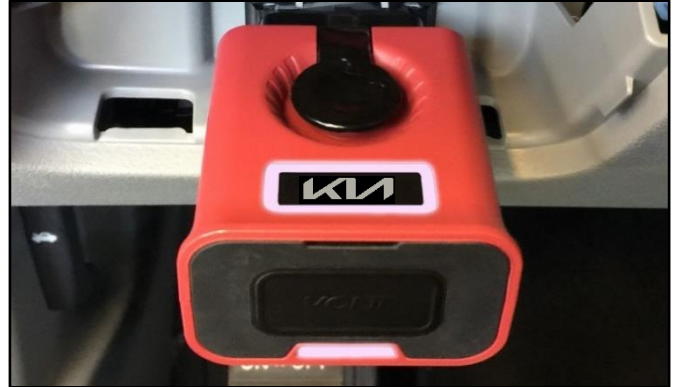
1. Connect the VCI-II to the OBD-II connector, located under the driver's side of the instrument panel.

The ECU upgrade function on KDS operates wirelessly. It is not necessary to perform the upgrade via USB cable.

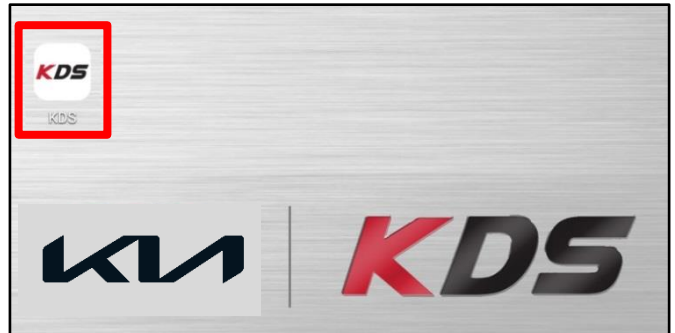
2. With the ignition ON, turn ON the KDS tablet. Select 'KDS' from the home screen.
